Supplemental monitoring of selected water bodies with contact recreation impairments.

SR-11-04

Water Resource Evaluation Section
Environmental Resource Management Division
Watershed Protection Department
City of Austin

February 2012

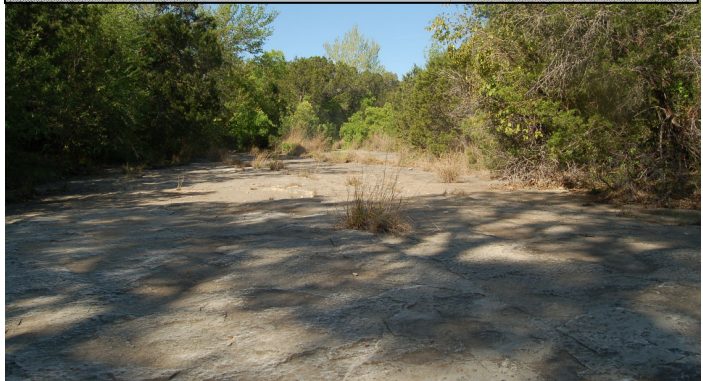
Figure 2. Eanes Creek downstream of Rollingwood Drive, April 8, 2009 (dry)

Wastewater collection systems in the Eanes Creek Watershed (**Figures 2-5**) are serviced in part by Austin Water Utility, in part by Travis County Water Control and Improvement District # 10 and in part by the Lost Creek Municipal Utility District. There is one Texas Land Application Permit (TLAP) facility using spray irrigation disposal for treated wastewater upstream, above the recharge zone, and numerous on site sewage facilities (OSSF) are present along the southern and western boundaries of the watershed (**Figure 5**). A single OSSF located approximately 950 ft south of the study site is believed to be abandoned according to COA records. The lower portion of Eanes Creek within the Edwards Aquifer recharge zone boundary is believed to flow only in immediate response to storm events. COA site #182 is located within a COA nature preserve. COA Site #182 was removed from the COA Environmental Integrity Index sampling program subsequent to 2001 due to a lack of flow (Clamann 2008, 2011). Some isolated pools may persist at this location during cool wet weather, but the stream channel within this reach is otherwise dry for most of the year (**Figures 2-4**).

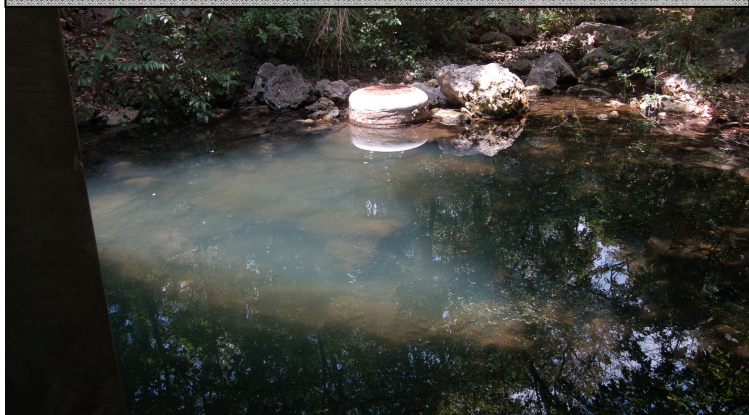
Figure 7. Sewer manhole in stream channel upstream of Ceberry Drive Bridge, August 12, 2009

The wastewater collection system in the Shoal Creek watershed (**Figures 6-11**) is operated by the Austin Water Utility. A single on-site sewage facility (OSSF) is operating in the upper portion of the watershed. Eleven other OSSF are located in the watershed but are believed to be abandoned according to COA records. One abandoned OSSF is located within the Spicewood Tributary drainage area approximately 3400 feet upstream of the TMDL monitoring site (**Figure 11**). Wastewater gravity collector pipes run down the length of the Spicewood Tributary, with manholes in the stream both upstream and downstream of Ceberry Drive at the immediate sample collection location (**Figures 7-8**). The Spicewood Tributary is heavily influenced by Spicewood Springs Road, stormwater runoff from other adjacent neighborhood streets (pavement chip-seal has been observed in the creek), and may also be influenced by adjacent single-family residences that abut the creek (**Figures 9-10**).
